UNITED STATES ENVIRONMENTAL PROTECTION AGENCY
REGION IX
75 Hawthorne Street
San Francisco, CA 94105

Re: E PA Conditional Approval of Atlantic Richfield's On-Property Focused Remedial Investigation Work Plan Amendment No. 12, Supplement No. 1—Task Sampling and Analysis Plan for Camp Isbell Hydrocarbon Investigation, Leviathan Mine Site, Alpine County, California, dated May 1, 2017

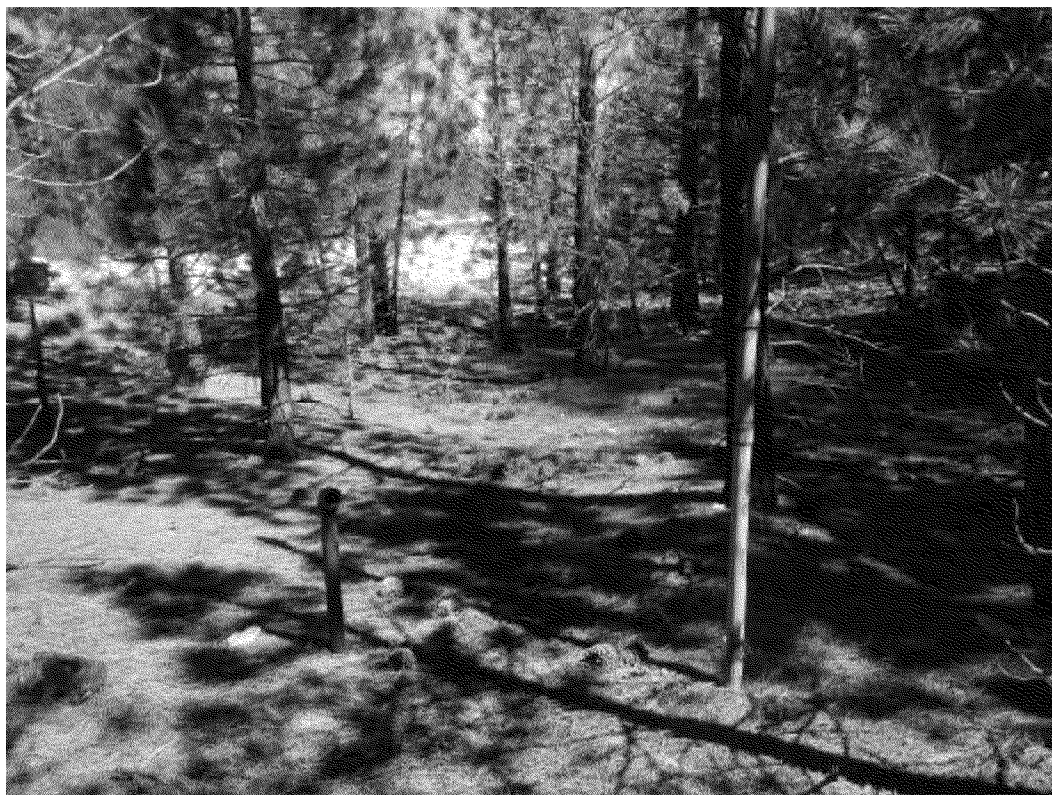
Attachment A: Photo 6131. View to northwest of two pipes that possibly indicated the presence of an underground tank at the former Camp Isbell area.

- **Add Sampling to Assess for Underground Storage Tank:** During our May 19, 2006 EPA site visit we identified a vent exhaust and stand pipe, that may indicate the presence of an underground storage tank in the former Isabel Camp area. Photo in Attachment 1. Please provide a full assessment, including samples and recommendations to ensure full assessment of the nature and extent of any associated contamination.

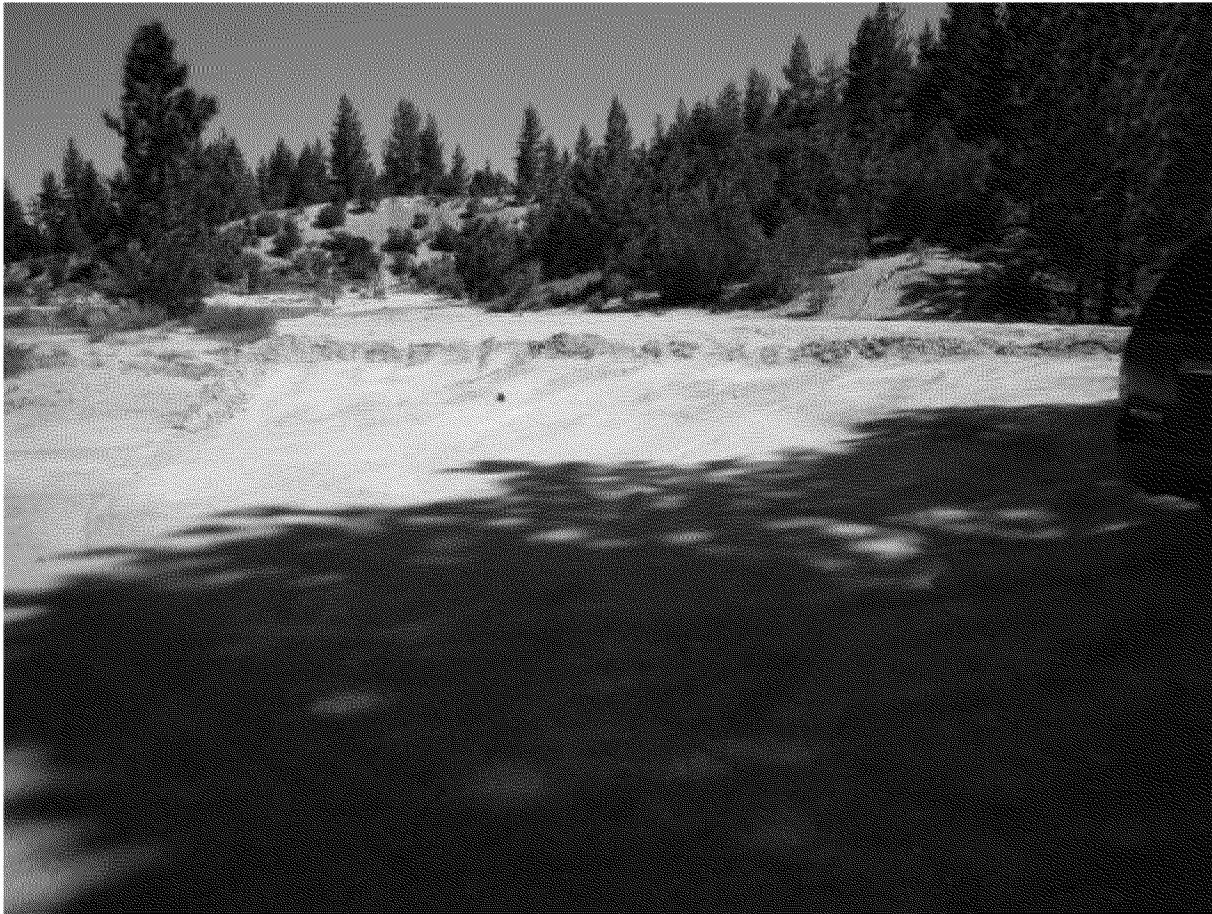
Attachment B: Photo 6133: View to north of a disturbed area of soil that appears to be a shallow excavation at the former Camp Isbell area.

In addition, EPA requests that ARC assess the area of disturbed soil. As discussed during our in person meeting on May 23, 2015: EPA was conducting a site visit to the Isabel Camp area on May 19, 2017 when we identified a disturbed area of soil that appears to be a shallow excavation at the former Camp Isbell area. Photo in Attachment 2. Please provide a full assessment, including historical sample concentrations of the soils in this area, and final placement of these disturbed soils within the next thirty (30) days or by June 24, 2017.
